Contract #: 04-0120F4Cty: SF/ALA Rte: 80 PM: 13.2/13.9File #: 13.28**WELDING INSPECTION REPORT****Resident Engineer:**Pursell, Gary**Address:** 333 Burma Road**City:** Oakland, CA 94607**Report No:** WIR-013713**Date Inspected:** 30-Apr-2010**Project Name:** SAS Superstructure**OSM Arrival Time:** 1000**Prime Contractor:** American Bridge/Fluor Enterprises, a JV**OSM Departure Time:** 1830**Contractor:** Oregon Iron Works Clackamas, Or.**Location:** Clackamas, OR

Bridge No: 34-0006**Component:** Hinge K Pipe Beams**Summary of Items Observed:**

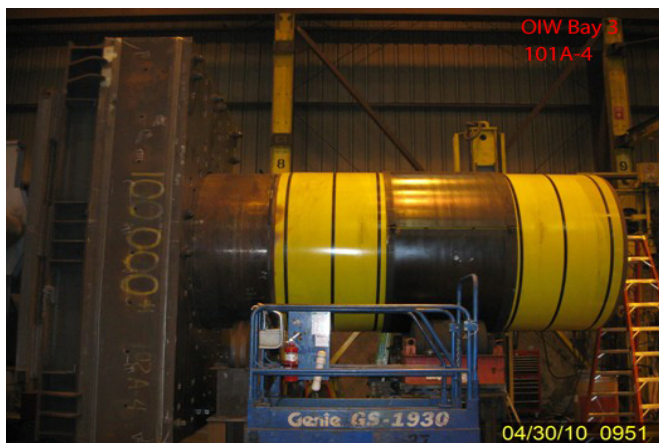
Hinge-K Pipe Beam Assembly 101A-4:

The QA Inspector was informed by OIW QC Inspector Jose' Salazar that he had performed Visual inspection on the exterior of the fit-up, on Weld Joint #W4-01. The QA Inspector noted that this Complete Joint Penetration (AWS D1.5 B-U7-S) was the Fuse 120A-4 to Forging 102A-4 and a total of four Flux Core Arc Welding (FCAW) tack welds, had been previously deposited, by OIW qualified welders. QC Inspector Salazar explained that the exterior of the fit-up was acceptable and that at this time, he does not have access to visually inspect the interior portion of the Weld Joint. QC Inspector Salazar explained that Swing Shift QC Inspector will perform this inspection, if access is provided.

The QA Inspector observed that Production Lead Troy Smith was present on this date and Lead Troy Smith explained that the Fuse perpendicular alignment had been verified by an OIW Machinist. Lead Troy Smith explained that the FARO Laser tracker had been utilized for this and that the Fuse alignment was .030" (.76 mm). The QA Inspector noted that per the contract requirements, the Fuse perpendicular alignment to Base weldment will be verified utilizing OIW's in house laser tracker and that cylinder concentricity to the pipe beam access is to be within +/- 1 mm (Sect. 10-1.59 Special Provisions). The QA Inspector noted that prior to OIW starting the Submerged Arc Welding (SAW), OIW production personell will have to set-up the welding machine and related accessories. The QA Inspector noted these include the stationary pre-heat torches, interior pre-fabricated access

scaffold on the interior and the water cooling boxes, to cool and protect the stainless steel overlay, during the SAW process. Lead Troy Smith explained that production work will continue throughout the shift on setting these items up and will probably continue on swing and possibly graveyard shift. Lead Troy Smith explained that no SAW will be performed, prior to these items being completed. See attached picture below.

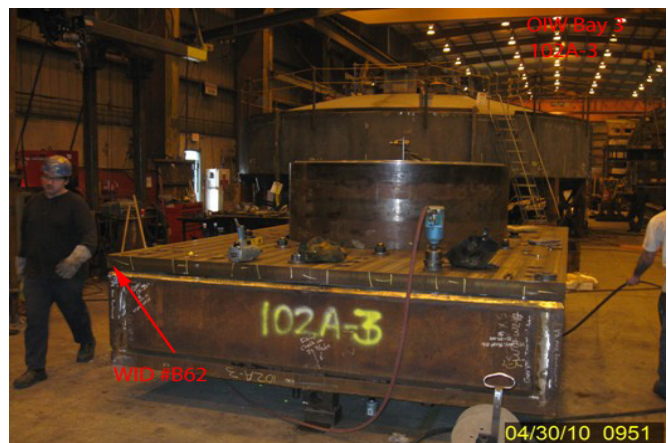
Hinge-K Pipe Beam Assembly 102A-3:

The QA Inspector was informed by OIW QC Inspector Jose' Salazar, that the Flux Core Arc Welding (FCAW) tack welding was now complete, on the a109 Post Tension Cap plate to HPS 485W stiffeners. QC Inspector Salazar explained that he was present during the tack welding and recorded in process welding parameters of 262 amps and 26.1 volts, with a pre-heat temperature of 400 degrees Fahrenheit. QC Inspector explained that the welding procedure specification 3049, had been utilized for the tack welding and WID #B62 had performed this in the horizontal (2G) position. The QA Inspector verified these welding parameters and pre-heat were in compliance with the applicable WPS. QC Inspector Salazar explained that he had verified the weld joint fit-up and accepted, after the tacking was complete and then he assigned weld joint numbers. The QA Inspector noted that these weld joint numbers assigned by QC Inspector Salazar were identical to the numbers assigned to the PJP's on the previous assemblies and are as follows: #W2-01 (a109 to b106), #W2-02 (a110 to b106), #W2-17 (a110 to b106), #W2-18 (a109 to b106), #W2-19 (a109 to a106), #W2-20 (a110 to a106), #W2-23 (a110 to ab106) and #W2-24 (a109 to ab106). The QA Inspector noted that these weld joints are designated, per the contract drawings, as AWS D1.5 Partial Joint Penetration TC-P4-S. The QA Inspector then verified the joint fit-up and the fit-up appeared to be in compliance with the contract requirements.

The QA Inspector later observed that OIW production had placed this assembly in the vertical position, in preparation for the Submerged Arc Welding (SAW) on the above mentioned PJP's. The QA Inspector spoke with Production Lead Troy Smith and he explained that WID #B62 (Marcus Belgarde) is currently setting up the welding machine and related equipment. Lead Troy Smith explained that once the equipment is set-up, pre heat will be established and a QC Inspector will be notified, prior to the SAW. See attached picture below.
